STATE OF WASHINGTON
DEPARTMENT OF CHILDREN, YOUTH, AND FAMILIES
OFFICE OF THE SECRETARY
1500 Jefferson Street, SE • P.O. Box 40975 • Olympia WA 98504-0975

September 13, 2023

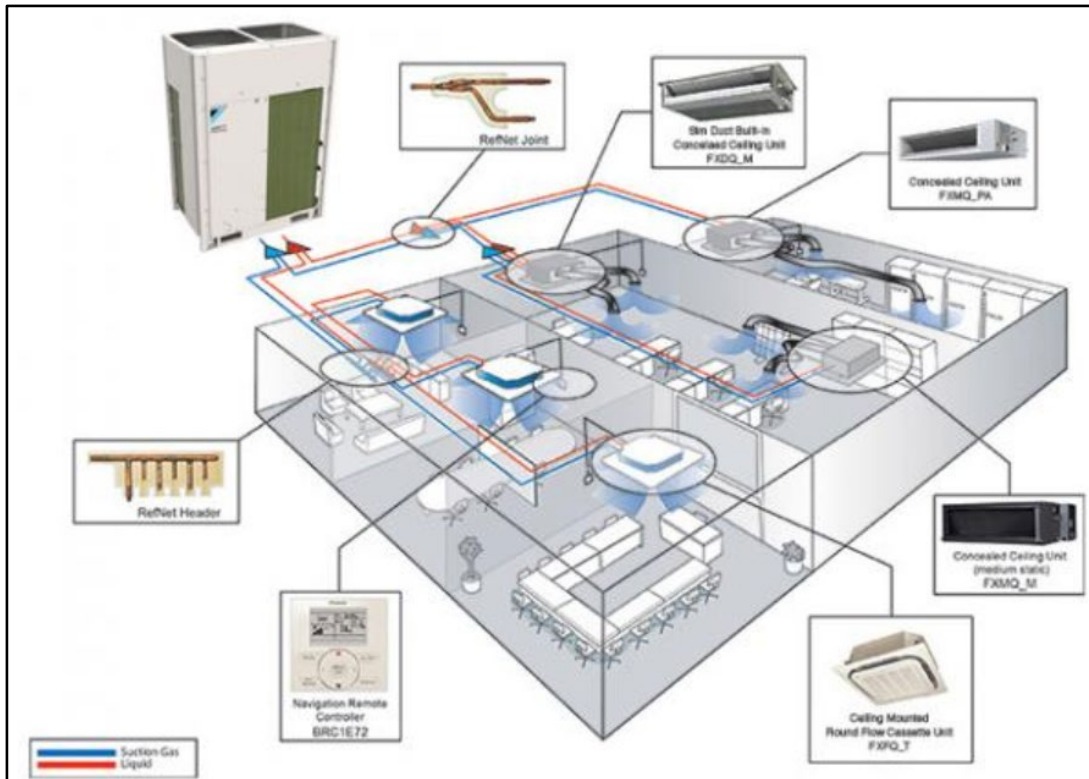
Efficient Direct Drive Fans

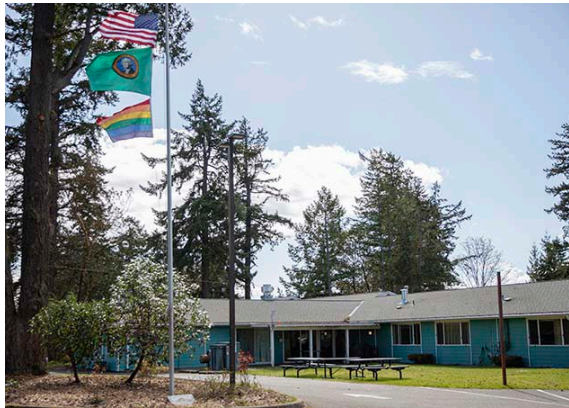
Oakridge Community Facility

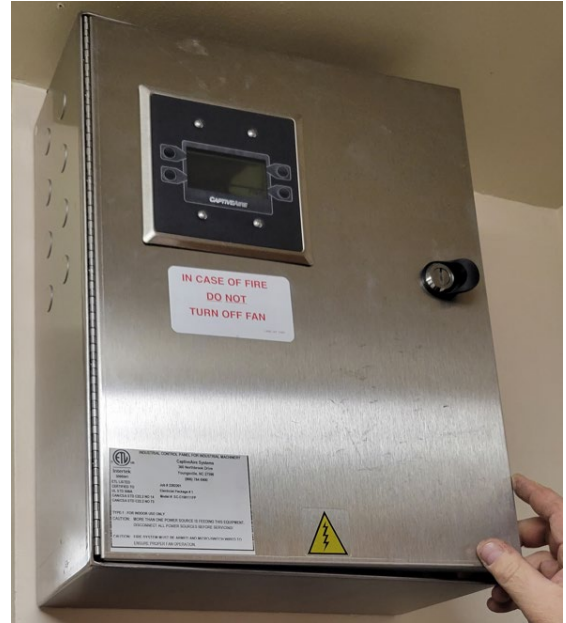
*Exhaust and Makeup Air Control Box.
Note display is damage and unusable*

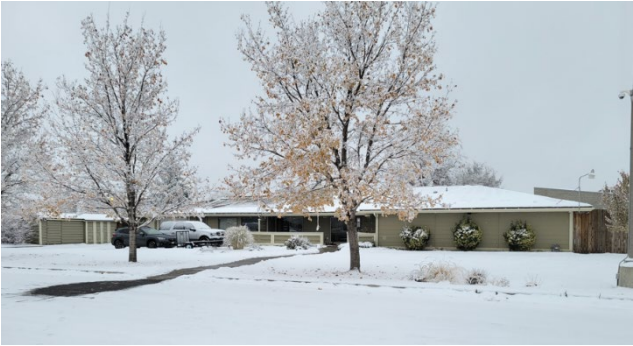
Parke Creek Community Facility

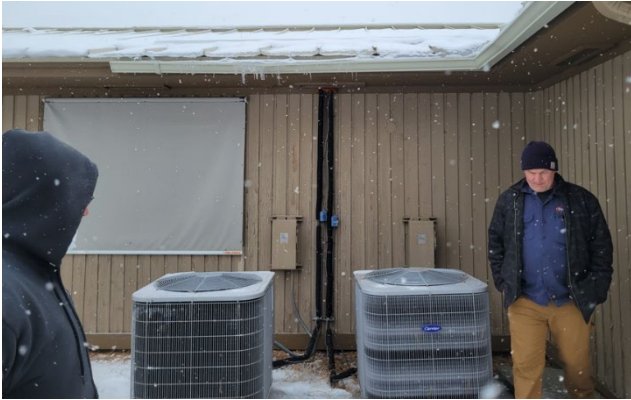
*Outdoor Condensing Units for Main Building Furnaces.
Refrigerant insulation is unjacketed and degraded*

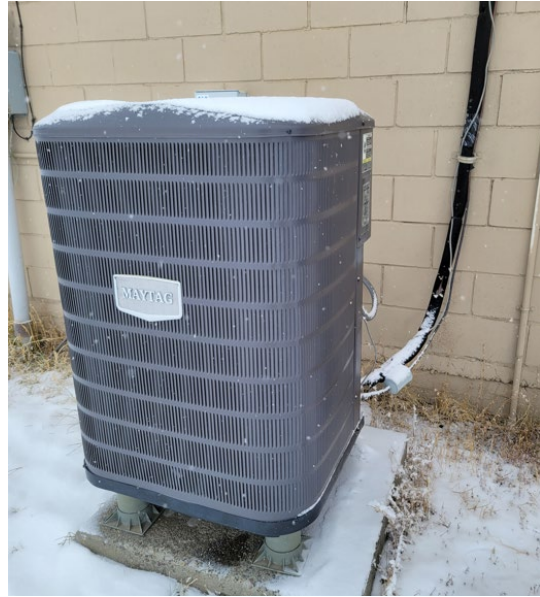
Classroom Condensing Unit

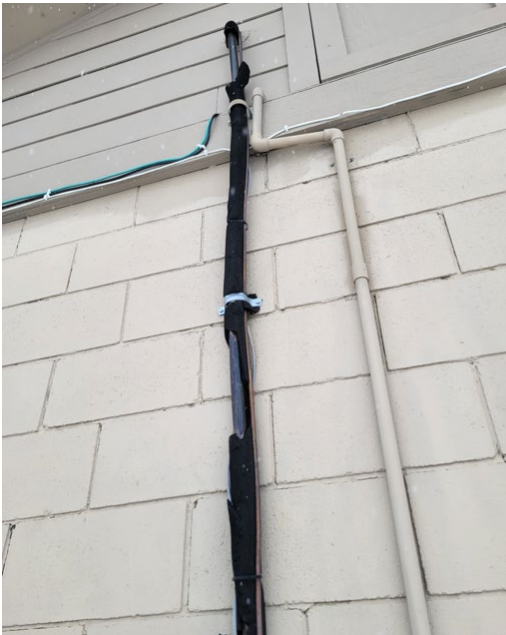
Classroom Refrigerant Piping with Degraded Insulation

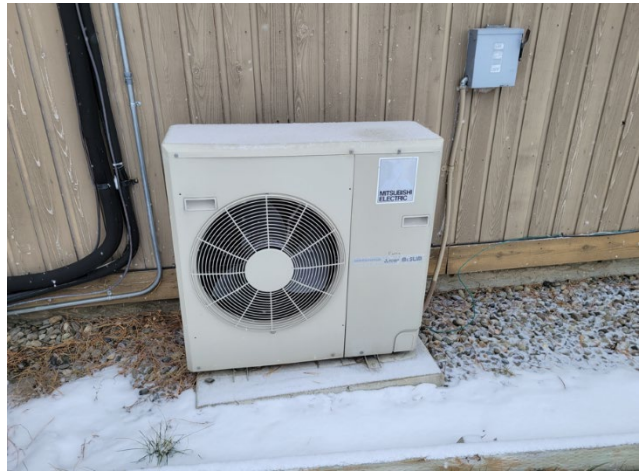
Dry Storage Outdoor Unit

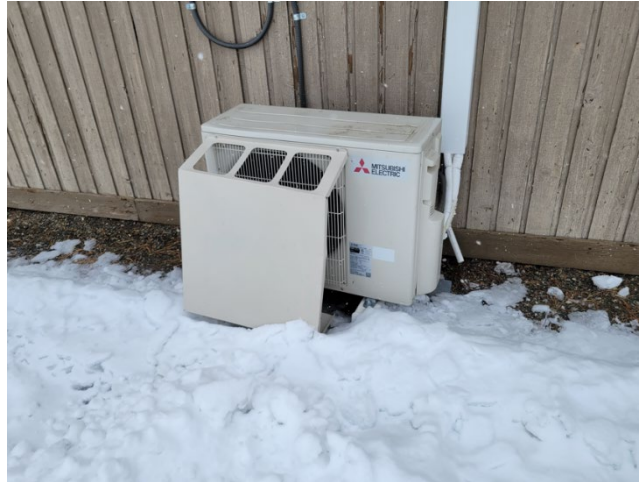
*Server Room Outdoor Unit
Note: Damage from Snowfall*

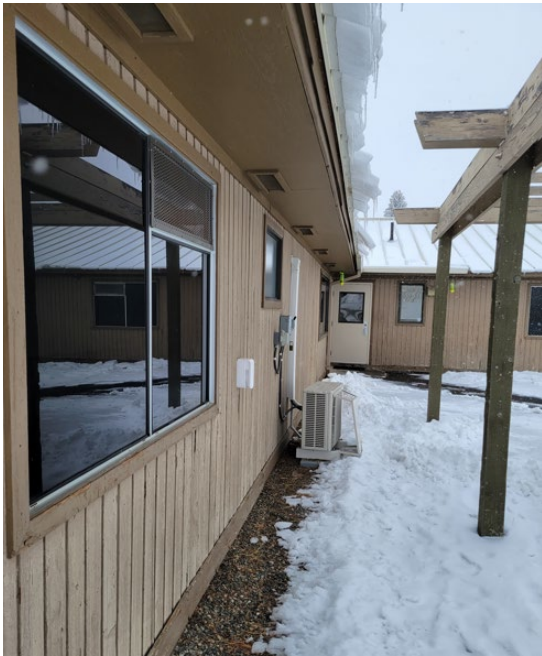
Server Outdoor Unit Located Directly Below Roof Edge

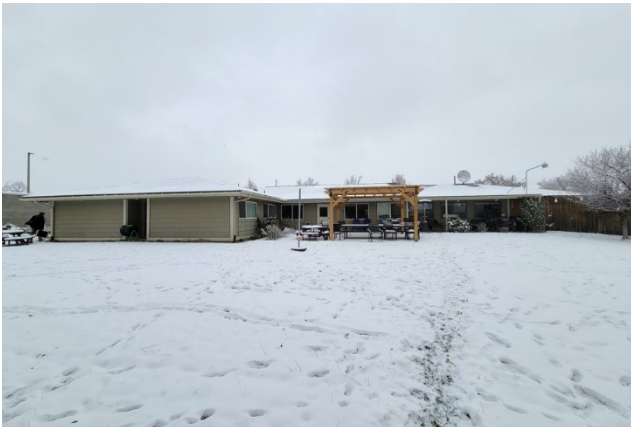
Ridgeview Community Facility

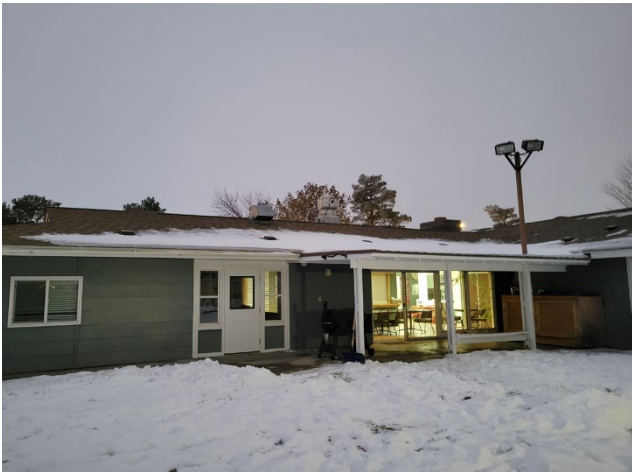
Sunrise Community Facility
Note: Air Intake and Kitchen Exhaust Fan

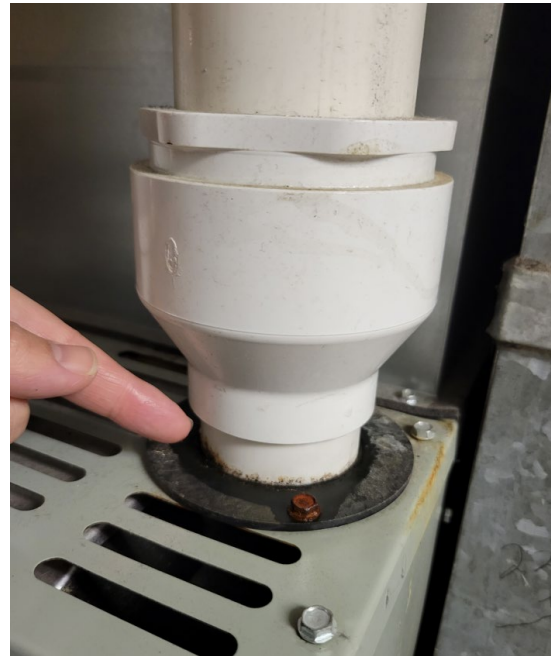
Flue Connection Leaking

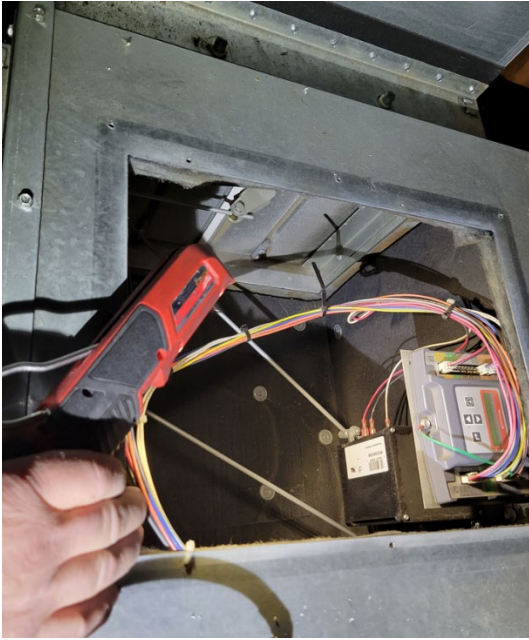
Second Floor Air Handling Unit

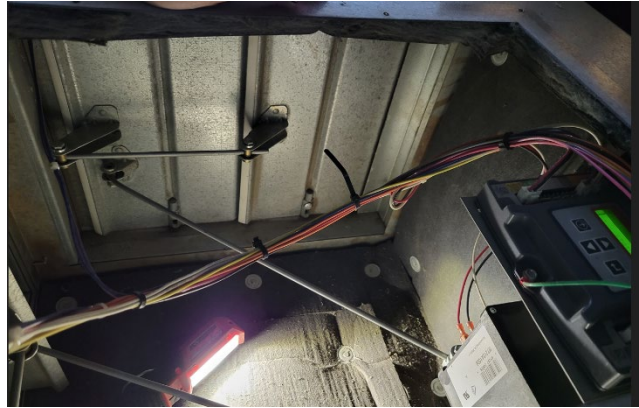
Outdoor Air Damper and Broken Actuator

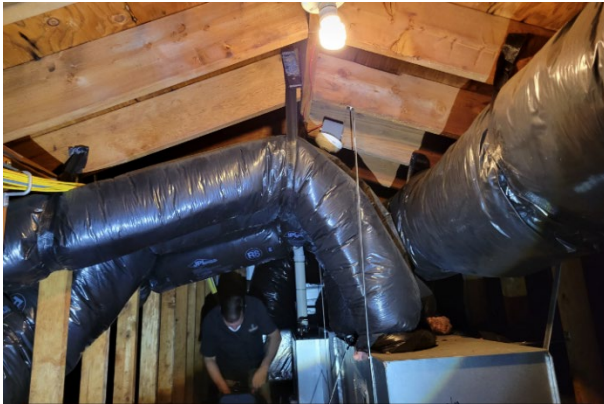
Second Floor System Supply Ductwork in Attic

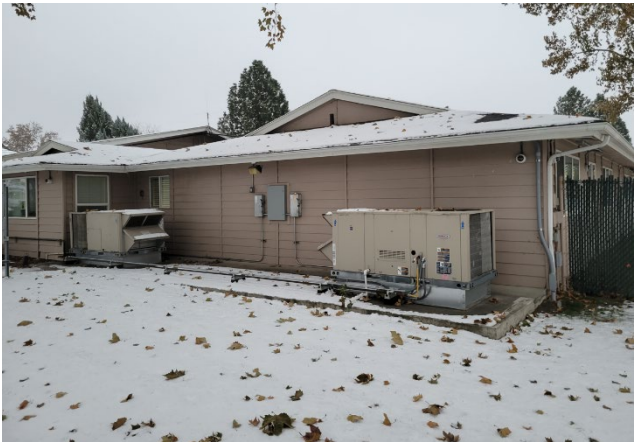
Twin Rivers Community Facility

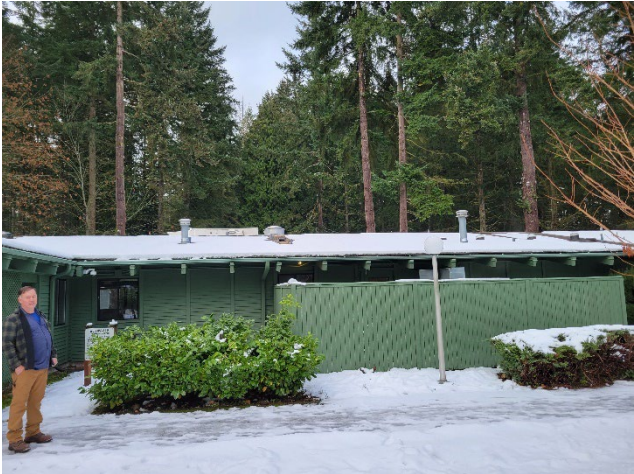
View of Facility from Parking Lot

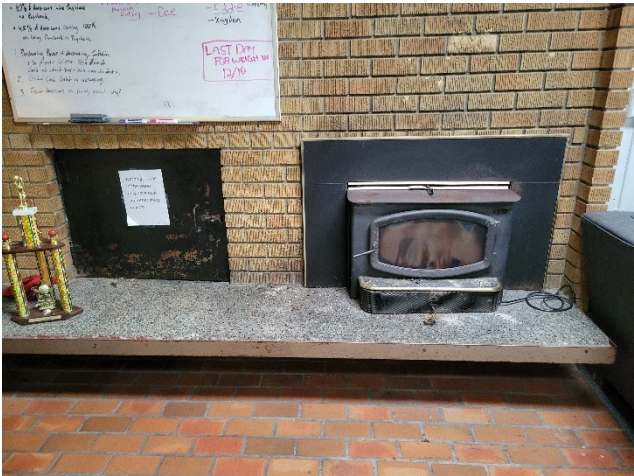
Wood burning stove and wood pass-through door

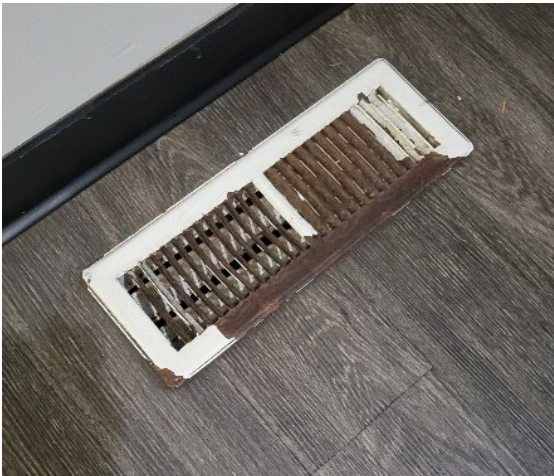
Floor Register near Entry

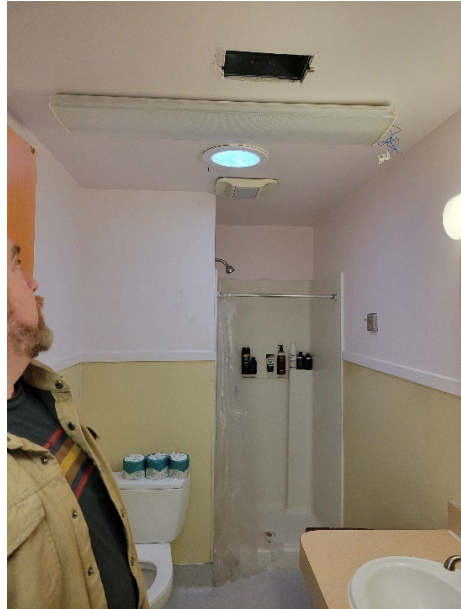
Typical Bathroom, Supply Grille Missing

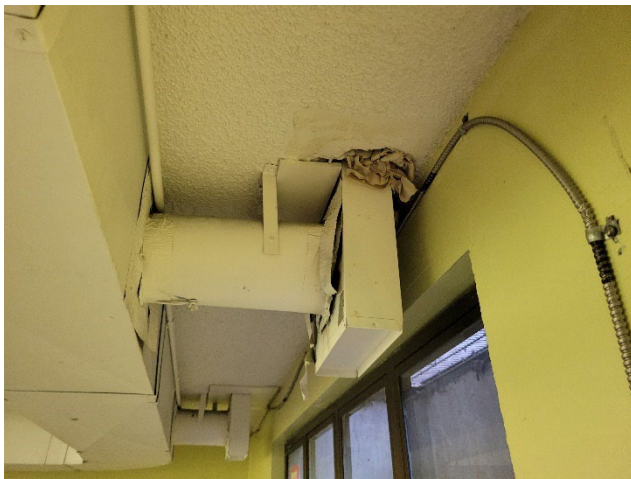
Ductwork to Furnace System Floor Grille

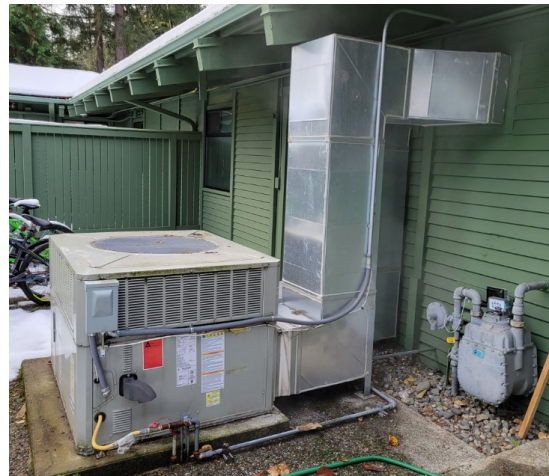
*Gas Fired Packaged AC Unit Serving Bedrooms
No Outdoor Intake. Note gas pipe is rusting where
combustion flue discharges directly onto it*

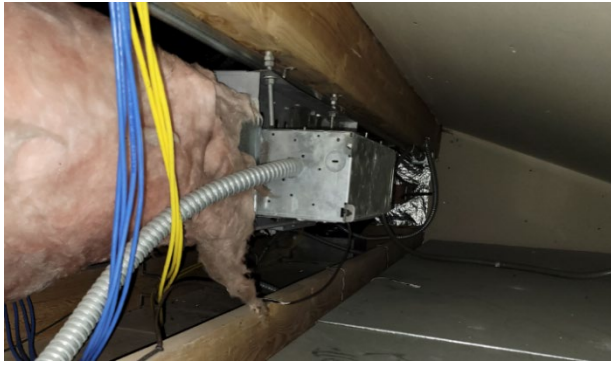
Kitchen Makeup Air Fan Coil in attic with Electric Heat

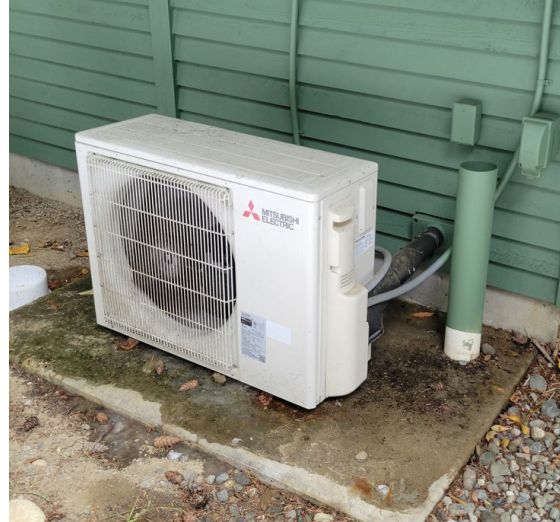
Server AC Outdoor Unit

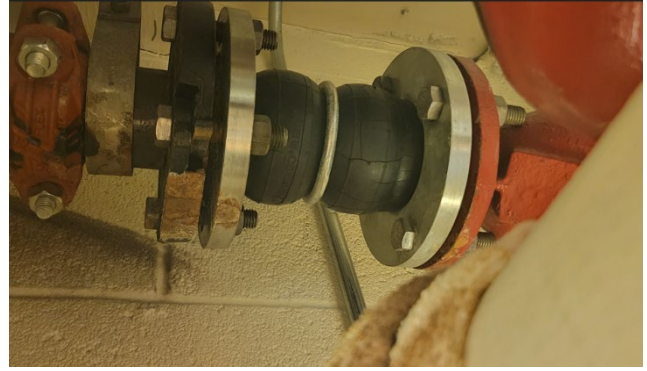
Pump Flexible Connection Stretched and Cracking

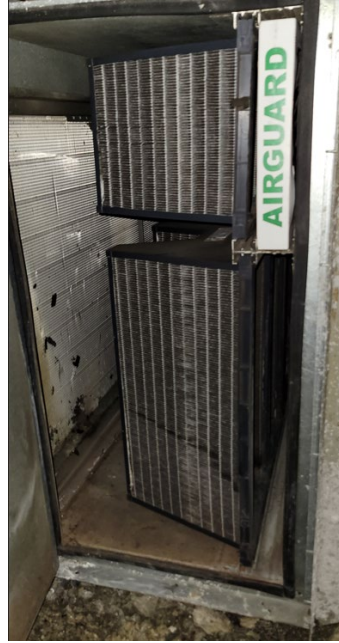
Prefilters and V-Bank Filters. Some prefilters are missing and coil needs cleaning.

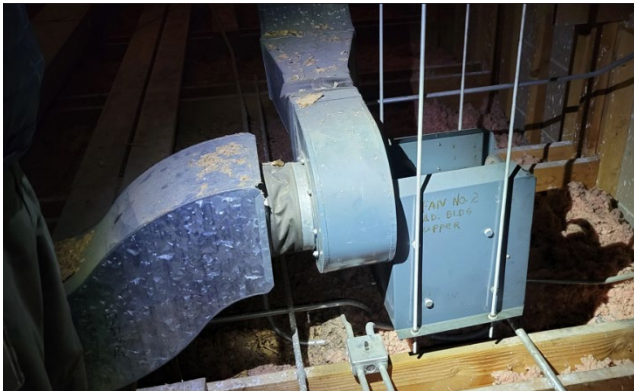
Exhaust Fans in Attic

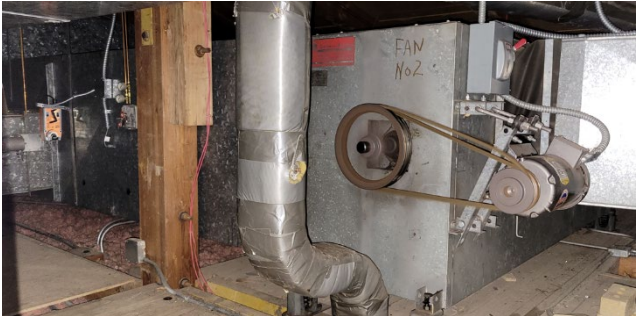
Air Handler
Note: One Belt is worn and slipping

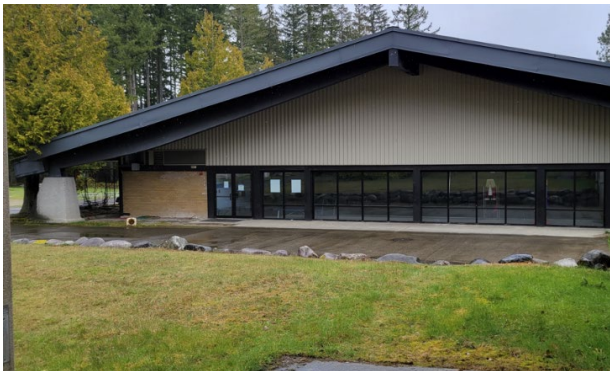
Recreation Building Facing Pool

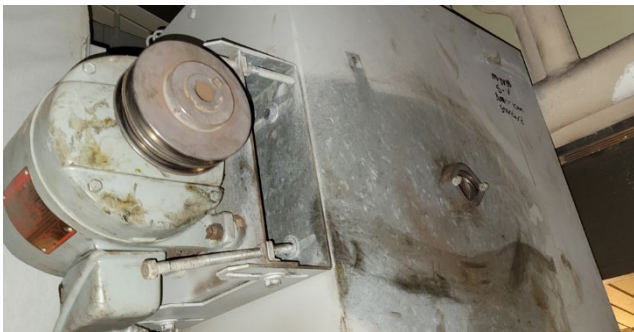
Unit for Weight Room and Offices with Broken Fan Shaft

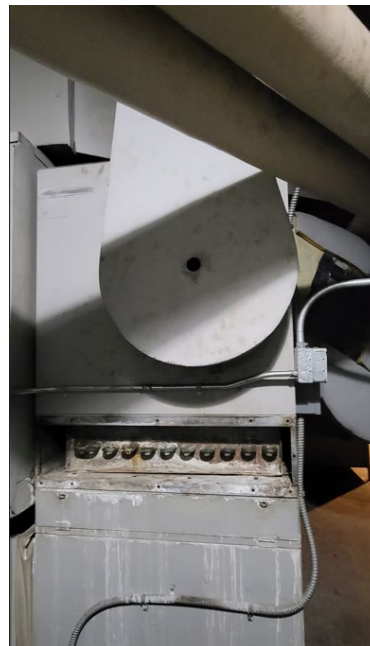
Heat and Vent Unit Serving Gym

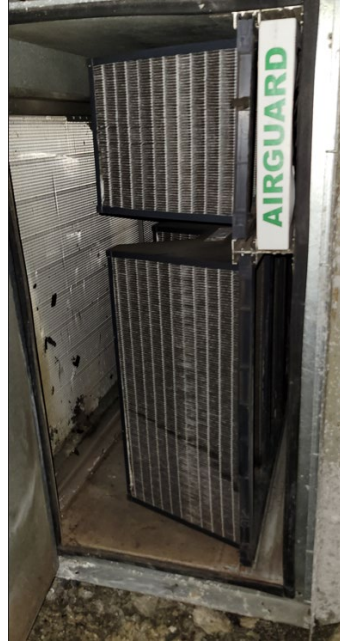
*Prefilters and V-Bank Filters. Some prefilters are missing
and coil needs cleaning*

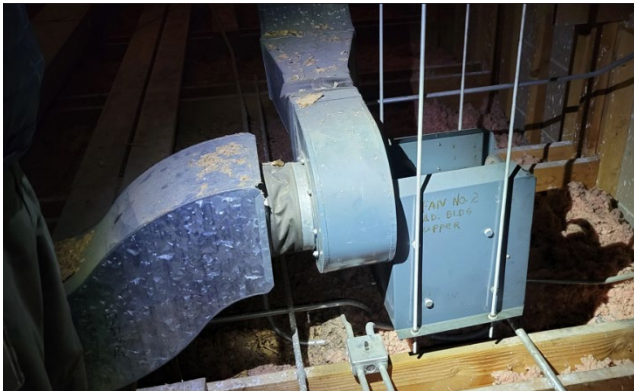
Exhaust Fans in Attic

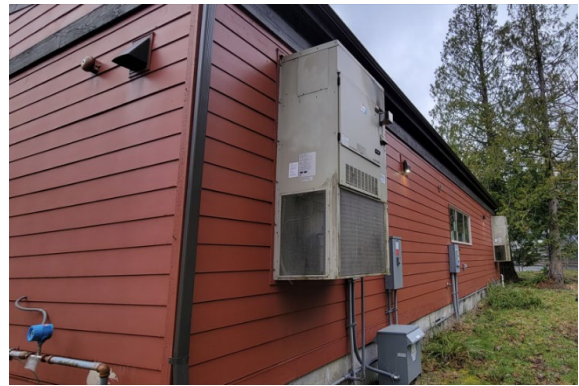
Air Conditioning Units on the Back Wall

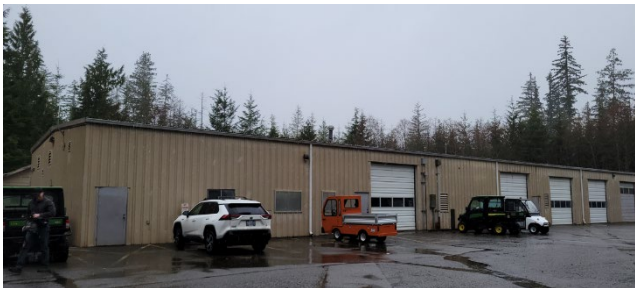
Maintenance Building

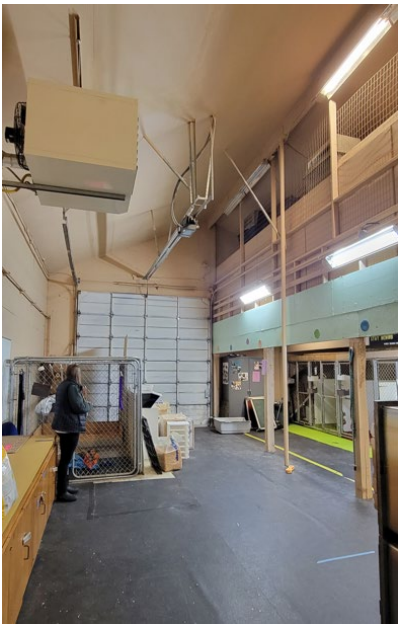
*Kennel Area
Unit Heater in Upper Left*

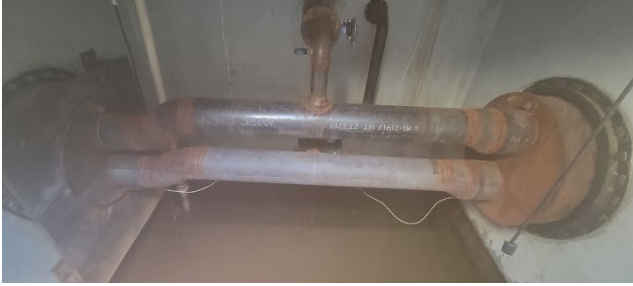
Pipe branch from main.

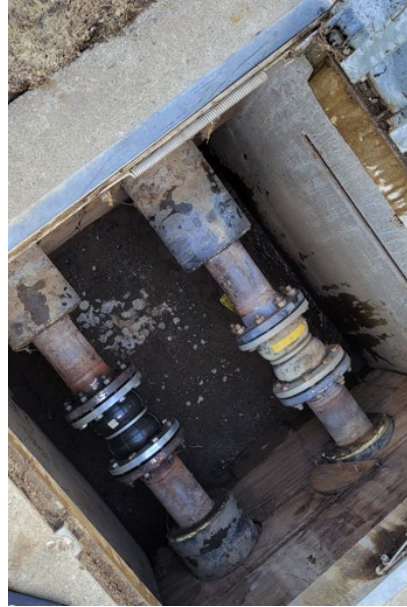
Small vault for expansion couplings on branch piping. Coupling on the left replaced after bursting.

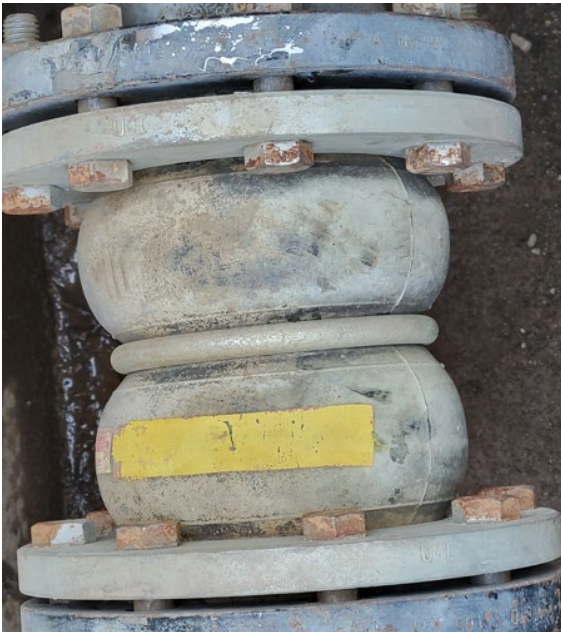
Original Expansion Coupling

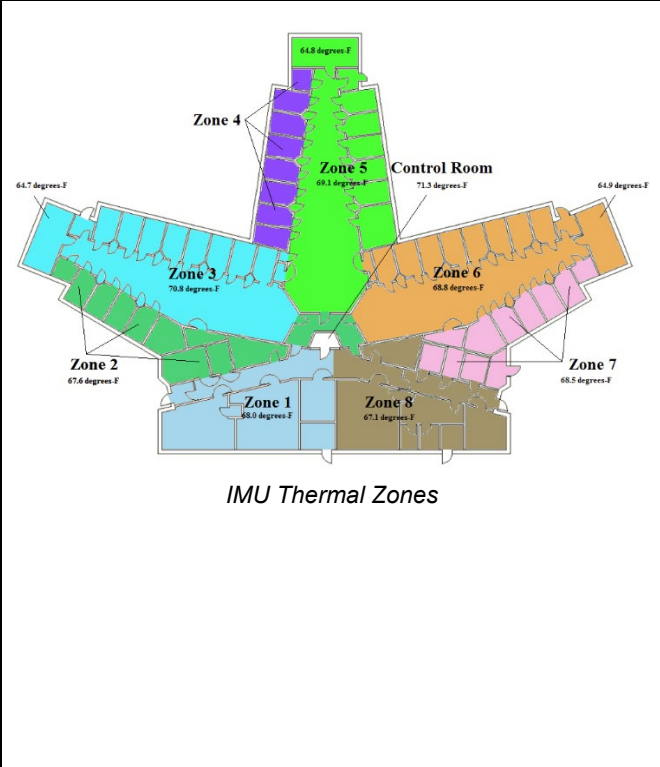
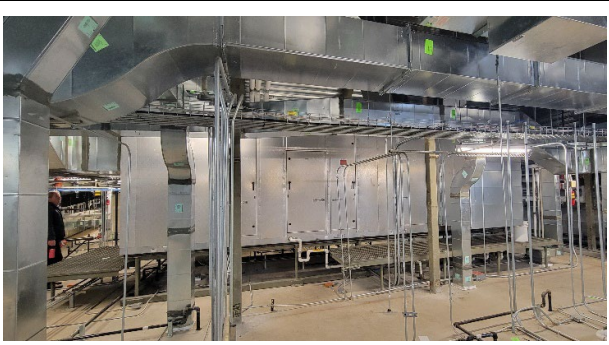
Mechanical Mezzanine and MZU-1

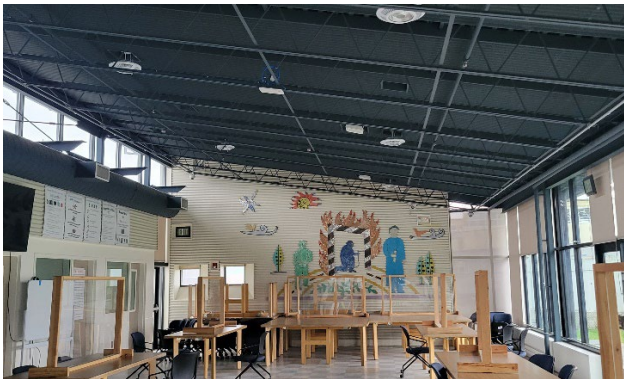
Group Visitation Room

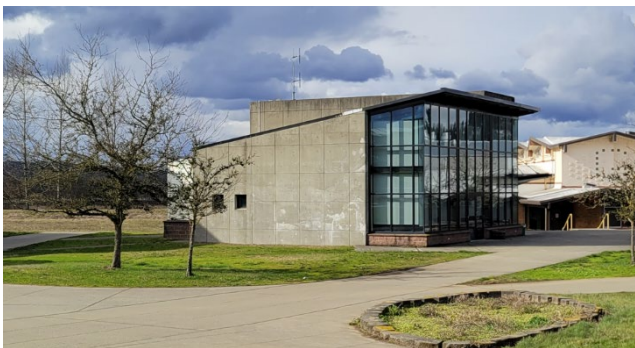
Multipurpose Building F

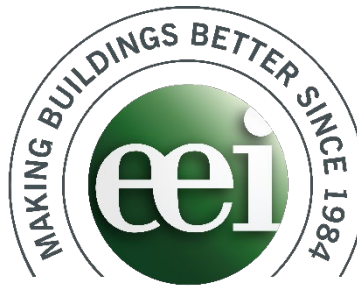
ENGINEERING ECONOMICS, INC.
